John's broken antenna

Connection Problems

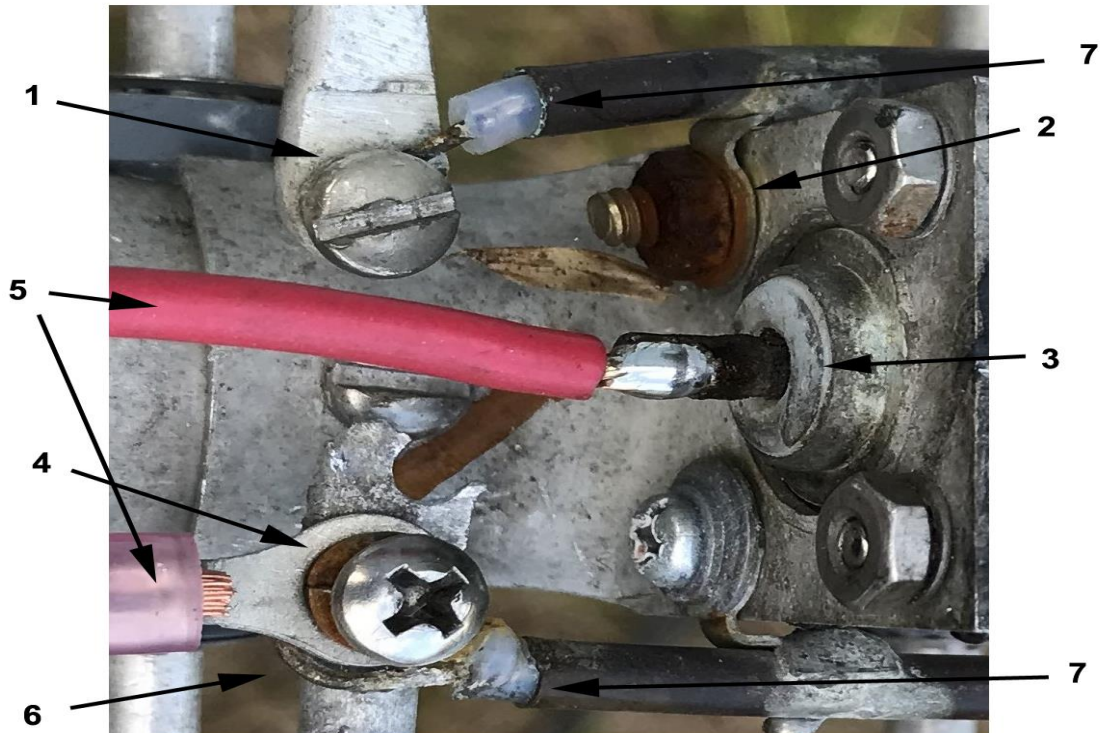
Figure 1 Multiple wiring and hardware errors

- 1.) Wires under screws with no lug or proper flat washers to sandwich
- 2.) Rusted critical hardware and both lugs technically go the wrong direction. Ideally grounds should be at the coax ends
- 3.) No weatherproofing, often will leak
- 4.) Wrong hardware and rusted hardware
- 5.) Wire crimped and far too long. Outdoor wire connections should be soldered or clamped, not crimp lugs
- 6.) Wire under the wrong hardware
- 7.) No water leak sealing or protection

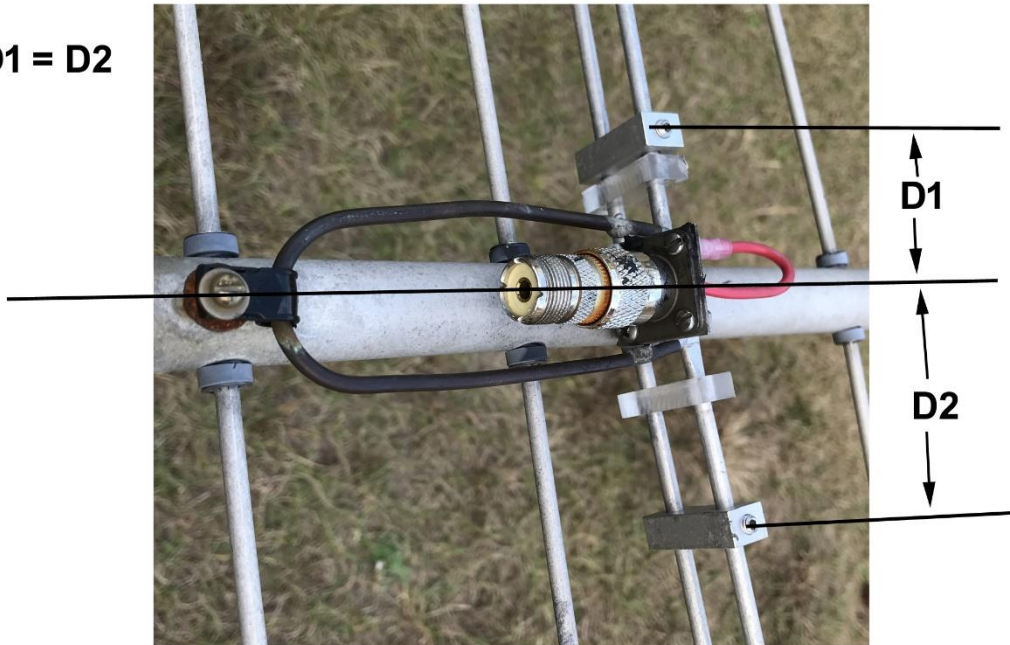
Figure 2 Symmetry error

1. D1 and D2 are not equal
2. Multiple other connection problems

T-match should be kept symmetrical to centerline

D1 = D2

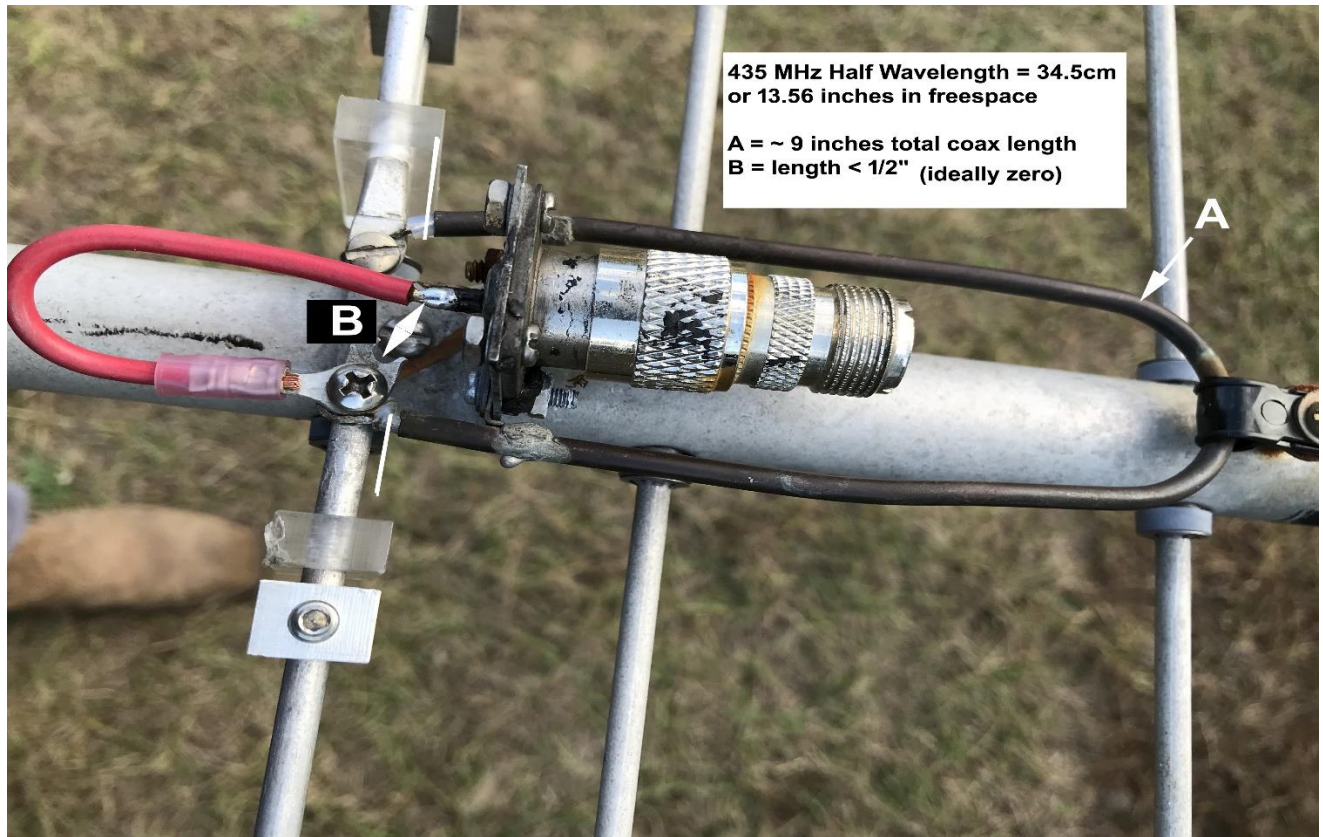
Figure 3 Wiring

A should be $\frac{1}{2}$ wavelength of a fairly low-loss reliable coaxial cable. The ideal cable impedance is 100-ohm, since each half of the T should look like 100-ohms and have near zero reactance.

B should be as short, wide, and smooth as possible. Plated copper strip or flashing would be ideal, solid wire second best, stranded third best choice and braided last choice. B should be a tiny fraction of a wavelength. Even one inch is too much at 432 MHz. Just one inch of connection length at 432 is like using 110 inches of connection length on 75 meters!!!

The higher the frequency the shorter connections must be.

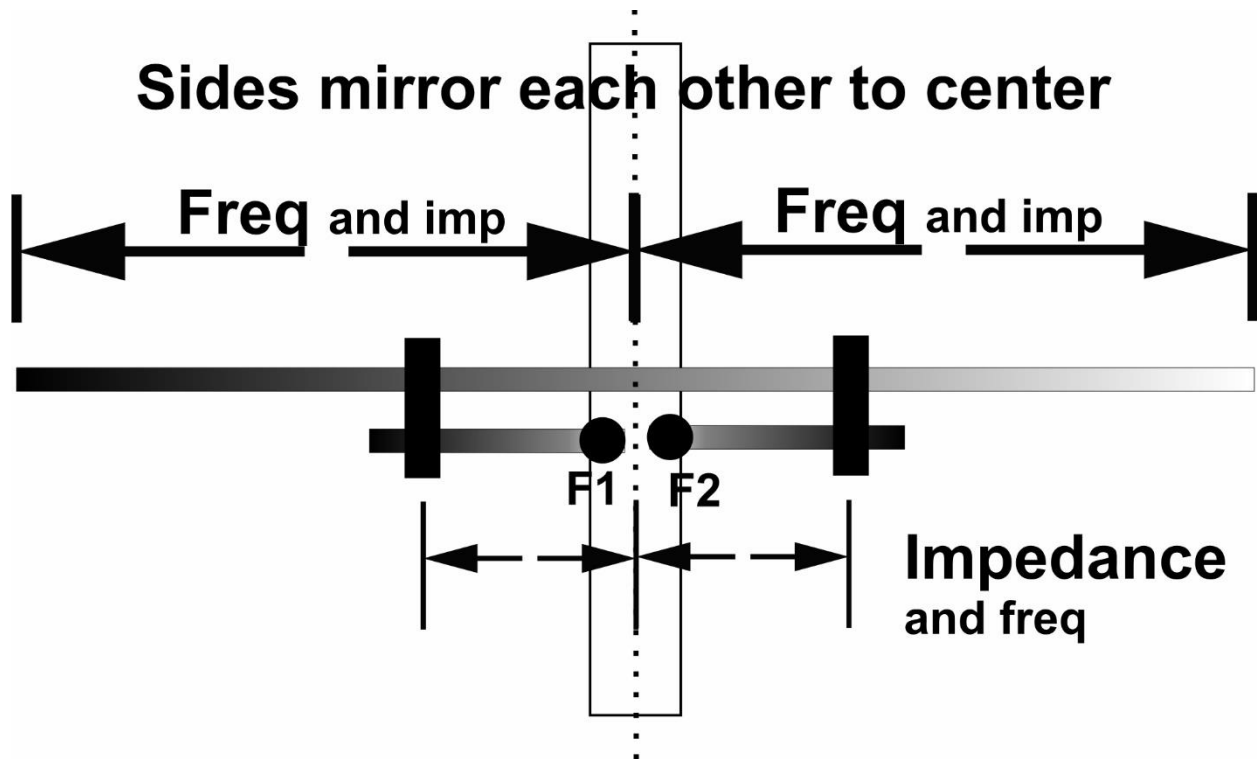
Figure 4 T-match simple operation rules

Everything must be symmetrical to the boom centerline. The **element length** primarily determines the resonant frequency (reactance) and secondarily determines the impedance.

The T tap-sliders primarily adjust the impedance (SWR) and secondarily affect the resonant frequency.

Adjustment is back and forth with element length and T-match sliders, but must be symmetrical

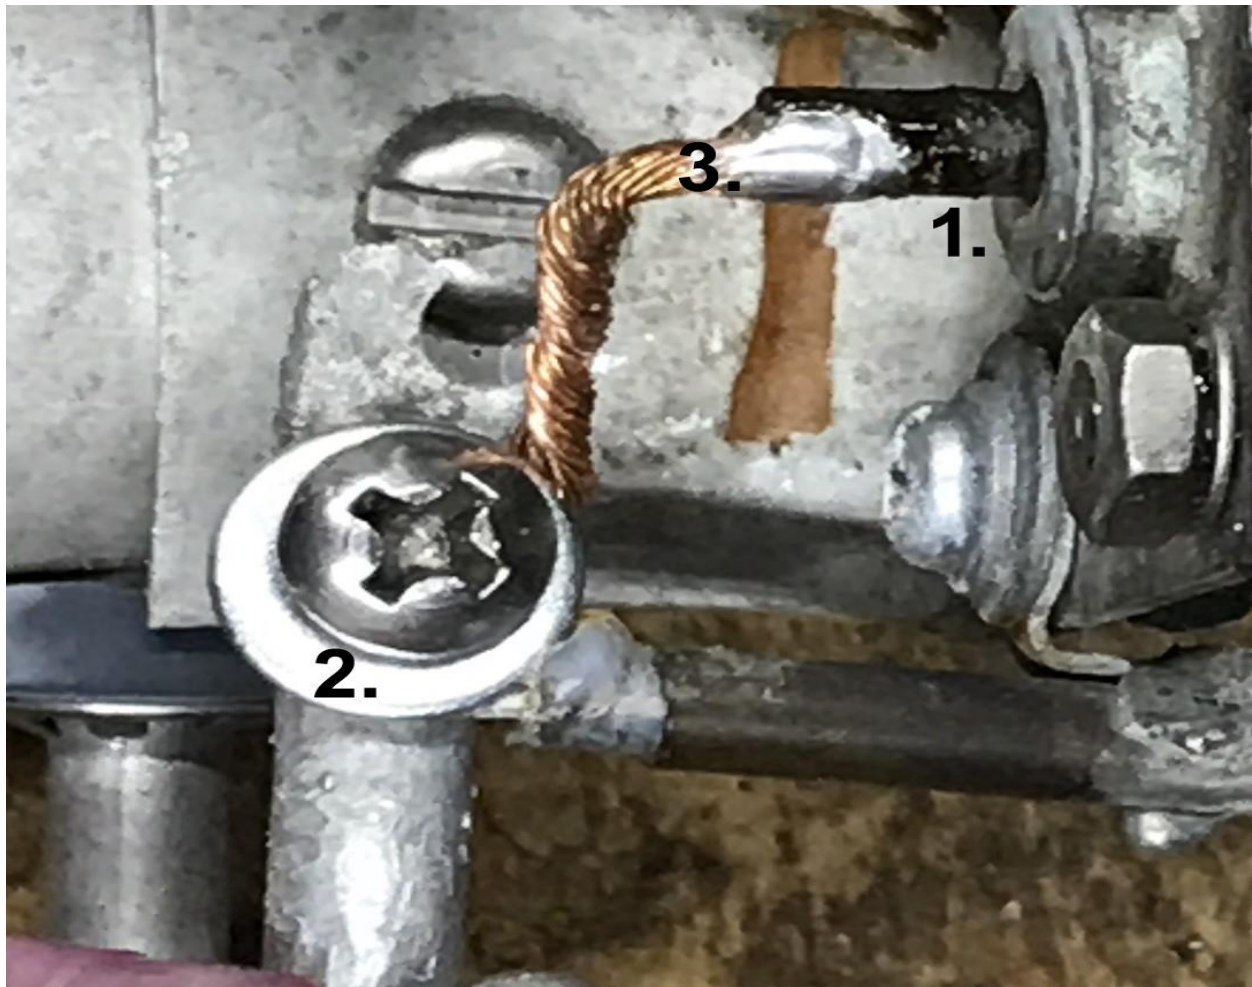
The feed point was cleaned up a great deal and will probably “work”

Figure 5 lower assembly errors

1. Needs sealed copper strip would have been better
2. Should have two stainless passivated washers, dielectric compound, and tension washers. Needs to be weatherproofed better with liberal use of dielectric compound

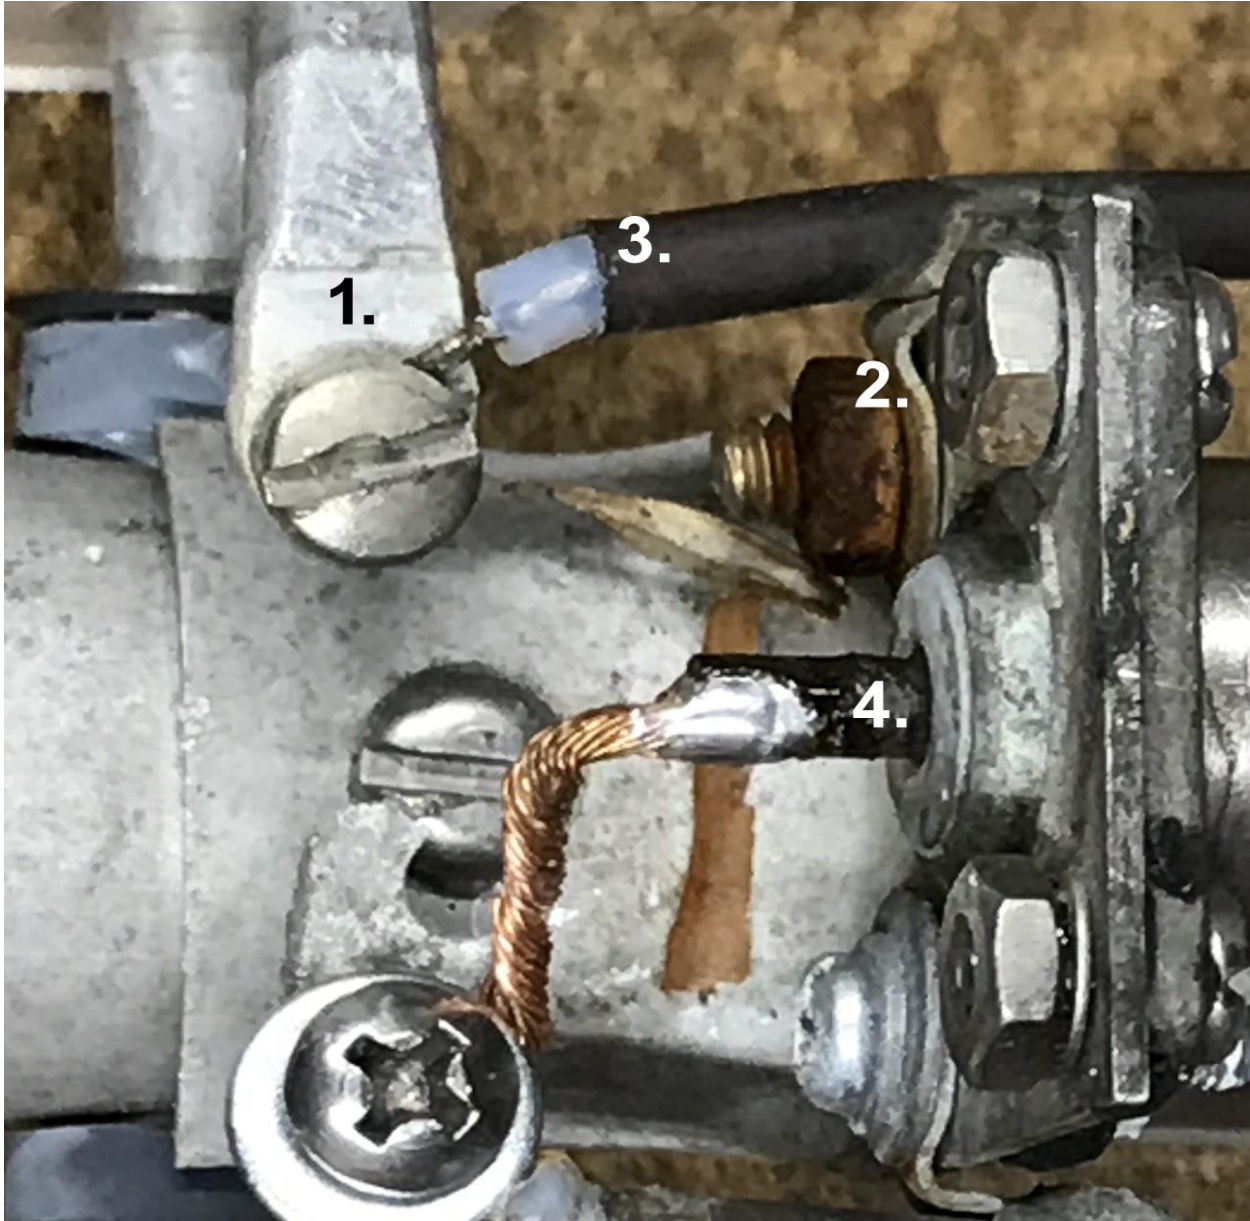
Figure 6 upper assembly errors

1. Needs new proper hardware. The wire should be between passivated stainless flat washers
2. Rusty zinc-steel hardware must be replaced with passivated stainless
3. Must be sealed
4. Must be sealed and the wire really should have been solid copper or better a wide, flat, plated or tinned copper strip
