John's repaired antenna

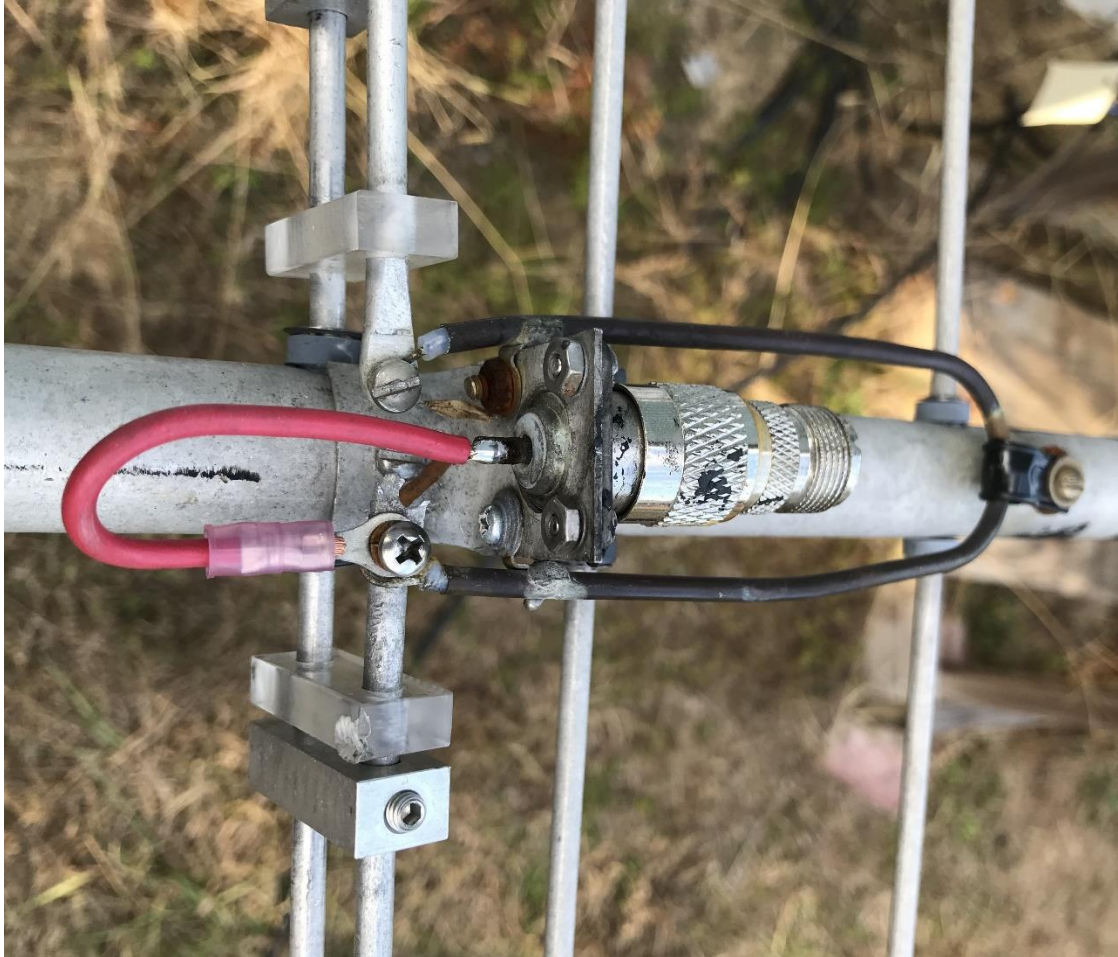
Figure 1 Multiple wiring and hardware errors

- 1.) Wires under screws with no lug or proper flat washers to sandwich
- 2.) Rusted critical hardware and both lugs technically go the wrong direction. Ideally, grounds should be at the coax ends
- 3.) No weatherproofing, often will leak
- 4.) Wrong hardware and rusted hardware
- 5.) Wire crimped and far too long. Outdoor wire connections should be soldered or clamped, not crimp lugs
- 6.) Wire under the wrong hardware
- 7.) No water leak sealing or protection
- 8.) Adaptor required
- 9.) Shorting bars incorrectly adjusted, uneven lateral spacing

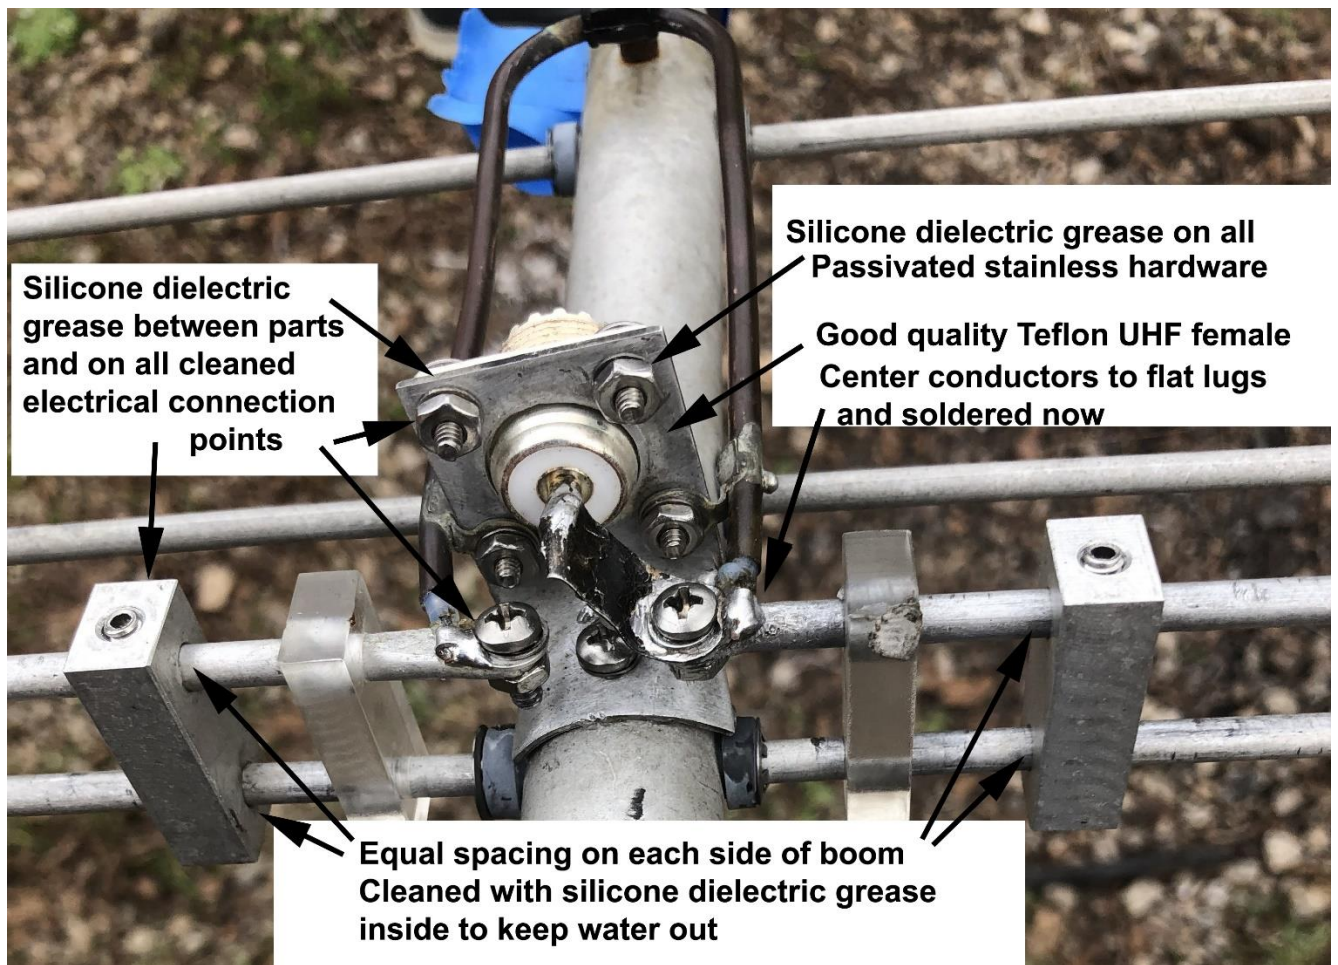
Figure 2 Corrected Hardware and feed

Corrected Feed

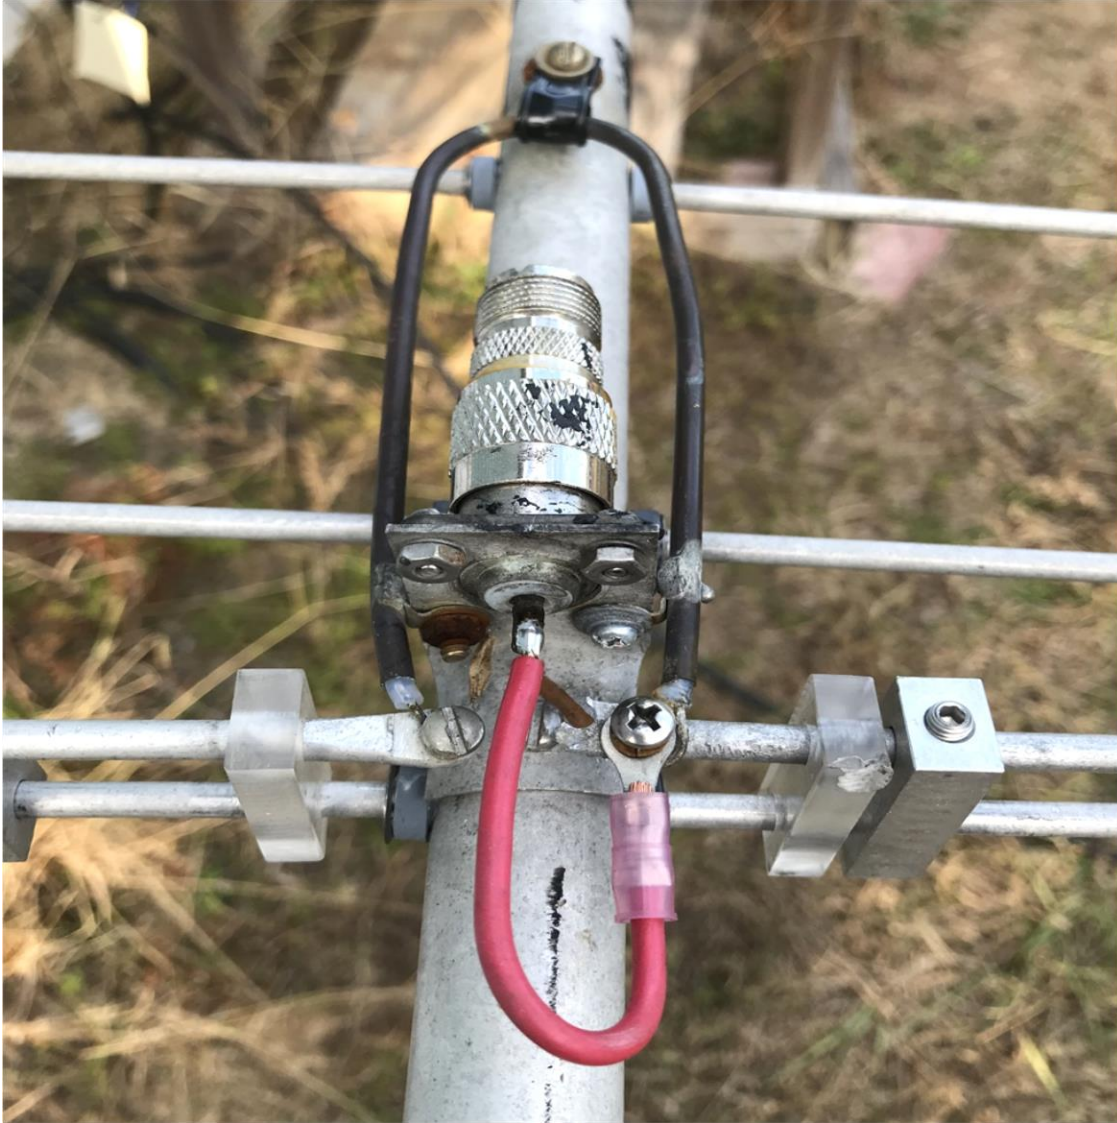
Figure 3 Uncorrected feed

Bad Feed

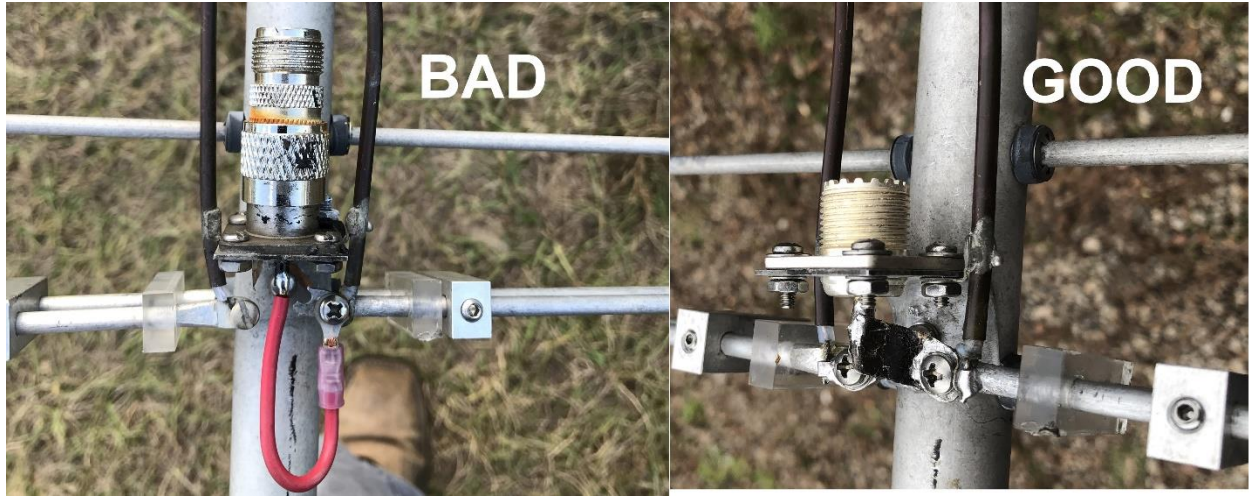
Figure 4 Bad and Good feeds

Bad and Good Feed

Note: It still needs weatherproofing. We suggested spraying critical points like rear of connector and the UHF connector with several coats of black Plasti-dip during the final installation
